Roadway Stagger Layout for Effective Control of Gob-Side Rock Bursts in the Longwall Mining of a Thick Coal Seam

Keywords Rock burst · Longwall mining · Roadway stagger layout · Tremor · Controlling measure

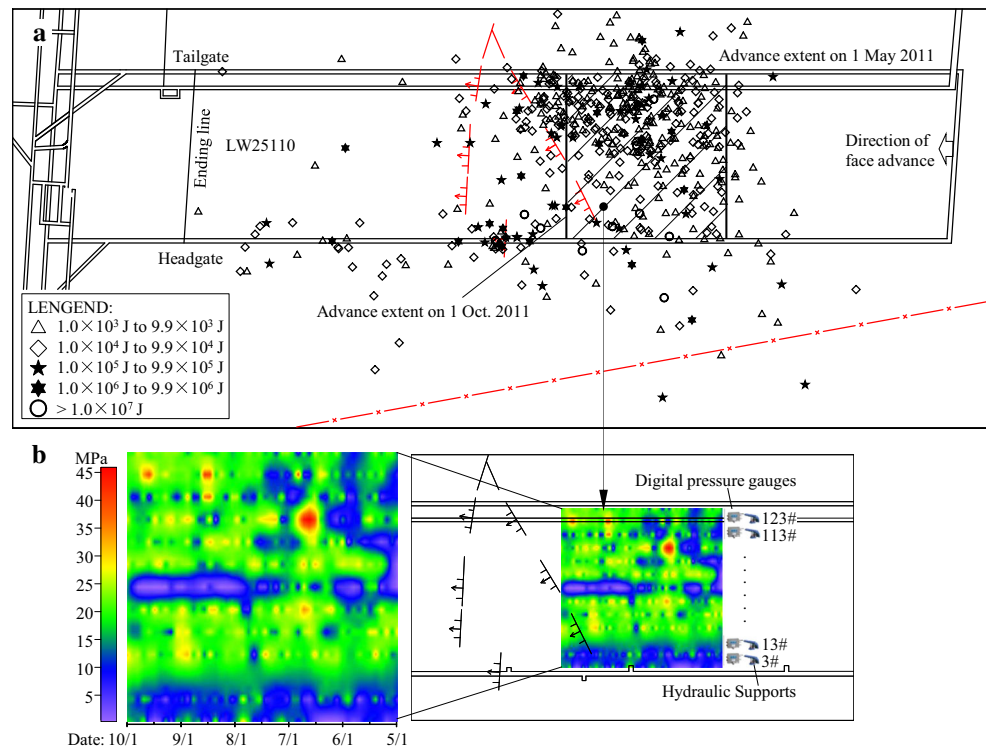
The ARAMIS M/E system (a microseismic monitoring system) developed by the Institute of Innovative Technologies (EMAG) of Poland was installed in YCM to locate tremors and rock bursts, determine energy released, and assess rock burst risk [refer to Li et al. (2014) for further details]. Figure 3a shows typical locations of and energy released by tremors as monitored by the system. It may be seen that a large number of tremors occurred near the tailgate.

The KJ216 mine pressure monitoring system was installed in LW25110 to investigate the support pressure. The system contains a total of 13 digital pressure gauges that were installed on hydraulic supports (from the third to the 123rd on every tenth support) to the longwall face. By correlating the pressure data with the extent to which the face had been advanced, it was found that the image map of the support pressures was as shown in Fig. 3b. It was seen that the pressure on those supports close to the tailgate (20–45 MPa) was higher than that on the supports close to the headgate (20–35 MPa, with 20–30 MPa accounting for the majority), which indicated that the coal body close to the tailgate bore a higher static stress.

Fig. 3 Monitoring data for LW25110 from 1 May 2011 to 1 October 2011: **a** typical locations and energy of tremors; **b** support pressure at the coal face. The shaded area in **a** was mined during this period of time

Figure 3a indicates that the majority of tremors occurred close to the tailgate, which implies that tremor-induced dynamic stress was supposed to be imposed on the coal-rock mass surrounding the tailgate more than that of the headgate. Figure 3b shows that the coal body close to the tailgate bears a higher static stress. In the case of normally arranged roadways (i.e., without using the roadway stagger layout method), the total stress within the coal-rock mass surrounding the tailgate was more likely to reach the critical stress level, which is the reason why GRBs account for the majority of rock bursts occurring in roadways. In addition, support of the tailgate is poorer and the tailgate only had a smaller number of controlling measures installed, as investigated in Sect. 2. All these factors mentioned above fooled us into thinking that the tailgate was under a higher rock burst risk (i.e., rock bursts were supposed to be more likely to occur in the tailgate rather than in the headgate). However, all the rock bursts occurred in the headgate, and the tailgate remained intact each time: this was abnormal. The main difference was the roadway stagger layout when comparing LW25110 with normally arranged panels, such as the roadway layout of Xing'an and Junde coal mines in Fig. 1. Therefore, it was concluded that it was the layout itself that generated this anomaly (i.e., the roadway stagger layout was favorable for GRB control).

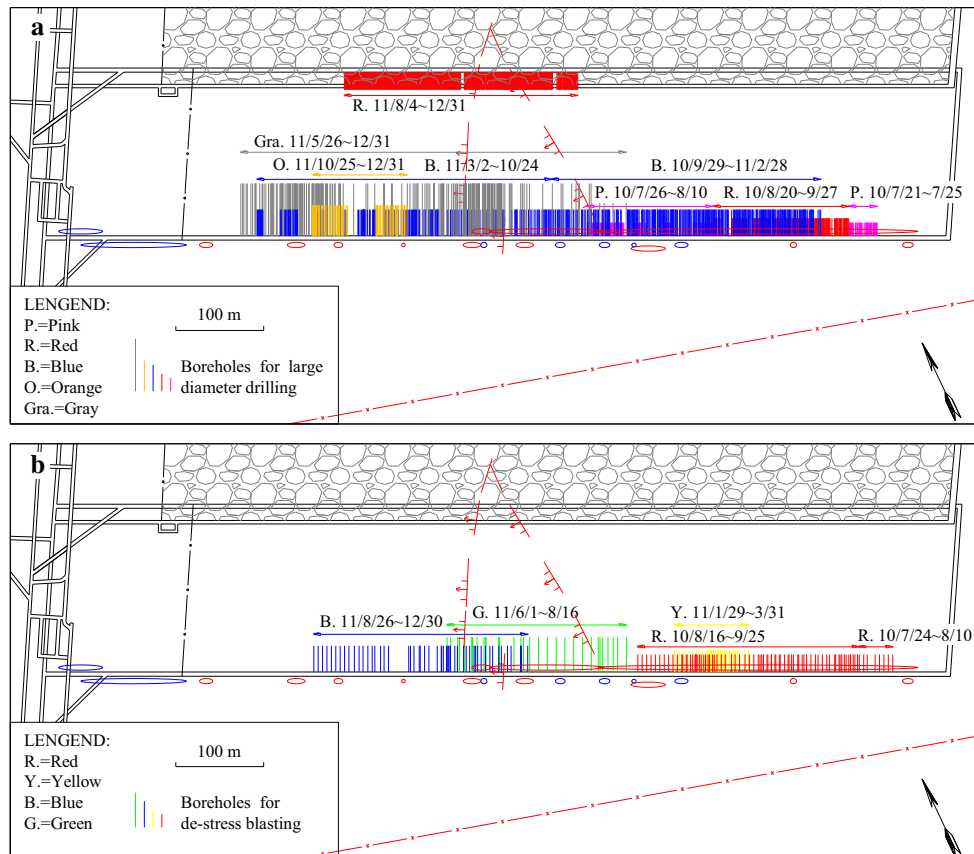
Rock burst control measures were taken more in the headgate than in the tailgate. Large-diameter drilling and de-stress blasting measures taken in LW25110 from 17 July 2010 to 31 December 2011 were investigated, as shown in Fig. 4 and Tables 1 and 2. About 235 boreholes for de-stress blasting were drilled along the headgate in the coal body and about 3210 boreholes for large-diameter

Fig. 4 Borehole layout for **a** large-diameter drilling and **b** de-stress blasting in LW25110 from 17 July 2010 to 31 December 2011

drilling were opened, of which 2445/765 boreholes were situated along the headgate/tailgate, accounting for 76.2/23.8 % respectively. Boreholes for large-diameter drilling and de-stress blasting along the headgate were approximately uniformly distributed and covered the entire roadway. However, boreholes for large-diameter drilling along the tailgate only covered a small proportion of the roadway. Tables 1 and 2 show that the parameters for large-diameter drilling and de-stress blasting along the headgate were improved five- and fourfold, respectively. Each time, the measures were enhanced.

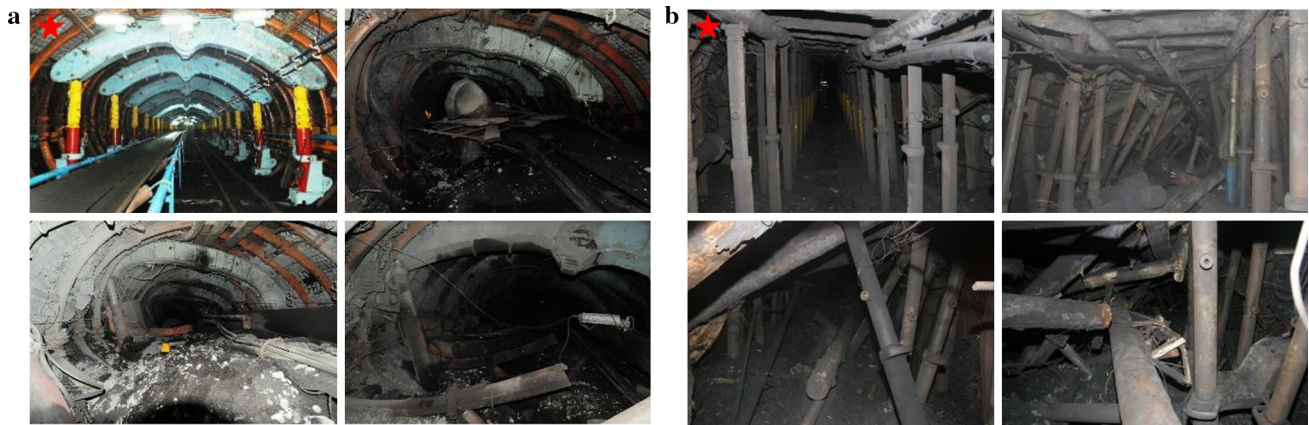
rock burst hazards. It is seen that the headgate (solid coal-side roadway) of LW25110 and the gob-side roadway in Xing'an coal mine (without using the roadway stagger layout method) were severely damaged. However, the gob-side roadway (i.e., tailgate) of LW25110 remained intact when each rock burst occurred.

Fig. 6 In situ record photos showing roadway support and rock burst hazards of **a** the headgate of LW25110 and **b** a gob-side roadway in Xing'an coal mine where the roadway stagger layout method was not

used. Photos with the *symbol star* were taken without a rock burst; others were taken after a rock burst

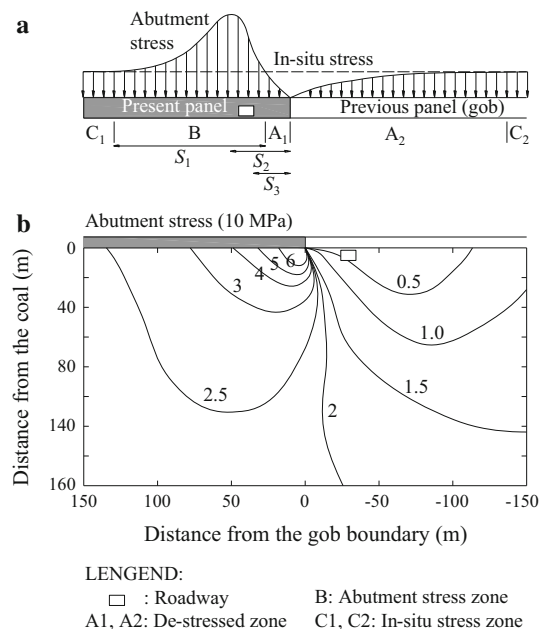
Figure 7 shows the vertical stress distribution adjacent to gob areas. There are an abutment stress zone and de-stressed zones in Fig. 7a. Field investigation (Qian and Shi 2003) shows that the abutment stress zone within the coal normally ranges from 15 to 30 m and can reach 35 to 40 m in a minority of cases, and that the abutment stress peak is usually 15–20 m away from gob (i.e., $15\text{ m} \leq S_1 \leq 30\text{ m}$ or $35\text{ m} \leq S_1 \leq 40\text{ m}$, and $15\text{ m} \leq S_2 \leq 20\text{ m}$). In cases of normally arranged roadways, the gob-side roadway is 6 to 30 m away from gob (i.e., $6\text{ m} \leq S_3 \leq 30\text{ m}$), which implied that the roadway lay mostly in the abutment stress zone. Figure 7b shows the numerical simulation result assuming that the cover depth was 800 m and the bulk unit weight of the overlying strata was 25 kN/m^3 . Thus, counter 2 is equal to the in situ stress. It is seen that the vertical stress within the floor and below the gob was much less than the in situ stress, which implied that the roadway is in a de-stressed zone in the case of a staggered layout. According to Fig. 7b, it was concluded that the vertical stress around the tailgate of LW25110 was less than 25 % of the in situ stress. This stress was significantly reduced when compared with normally arranged cases.

Fig. 7 Vertical stress distribution within **a** the coal seam and **b** the floor strata adjacent to gob areas. **b** Derived from Qian and Shi (2003)

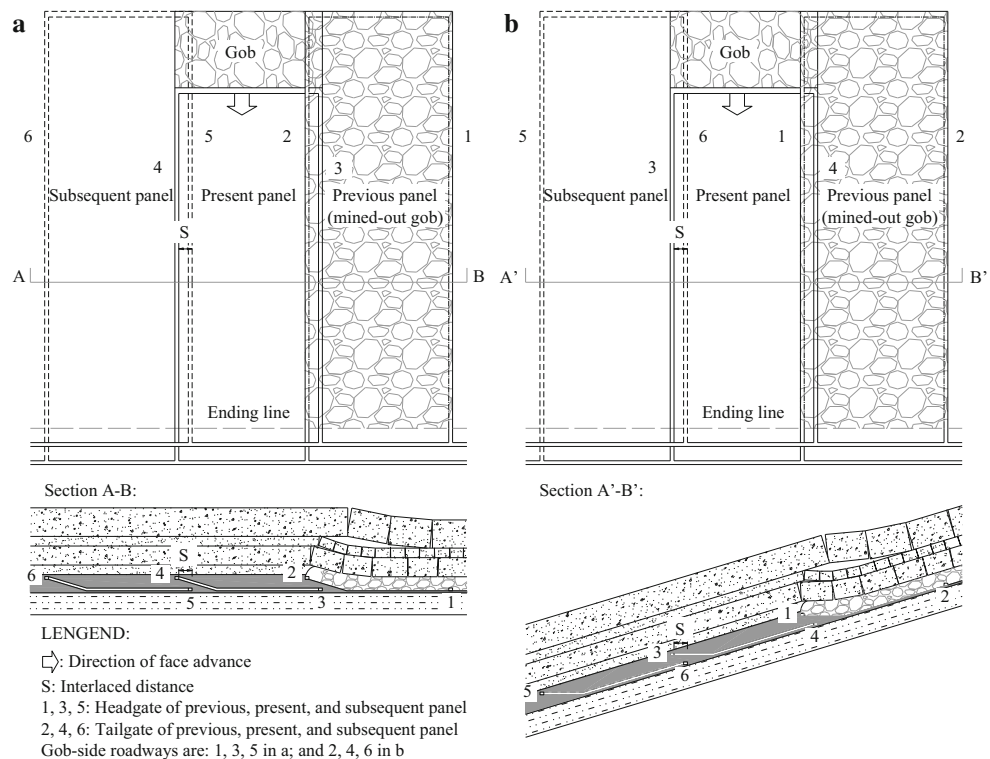
- The headgate and tailgate of a longwall panel are located at different horizons within a thick coal seam (i.e., along the top or bottom of the coal seam): when the inclination is small, the headgate (gob-side roadway, used for inputting fresh air) is disposed along the bottom of the coal seam, and the tailgate (solid coal-side roadway, used for outputting waste air) is disposed along the top of the coal seam, as shown in Fig. 8a; when the inclination is large, the headgate (solid coal-side roadway, used for inputting fresh air) lies along the top of the coal, and the tailgate (gob-side roadway, used for outputting waste air) lies along the bottom of the coal, as shown in Fig. 8b.

Fig. 8 The staggered roadway layout system in a thick coal seam with **a** a small inclination and **b** a large inclination

- The gob-side roadway (headgate or tailgate) is arranged so as to sit just below the previous mined-out panel.
- Adjacent panels are interlaced and there are no coal pillars between them.
- The interlaced distance S (i.e., the distance from the gob-side roadway of the present panel to the solid coal-side roadway of the previous panel) is normally not less than 3–5 m according to certain mining-geological conditions.
